2. Palmer Station (07/01/18 – 03/29/19)

This sections describes quality control of solar data recorded at Palmer Station between 07/01/18 and 03/29/19. This period resulted in a total of 15,698 solar scans, which were assigned to Volume 28. There was a site visit at the end of the reporting period. With the following exceptions, the system operated normally and there are only very few data gaps (Section 2.4):

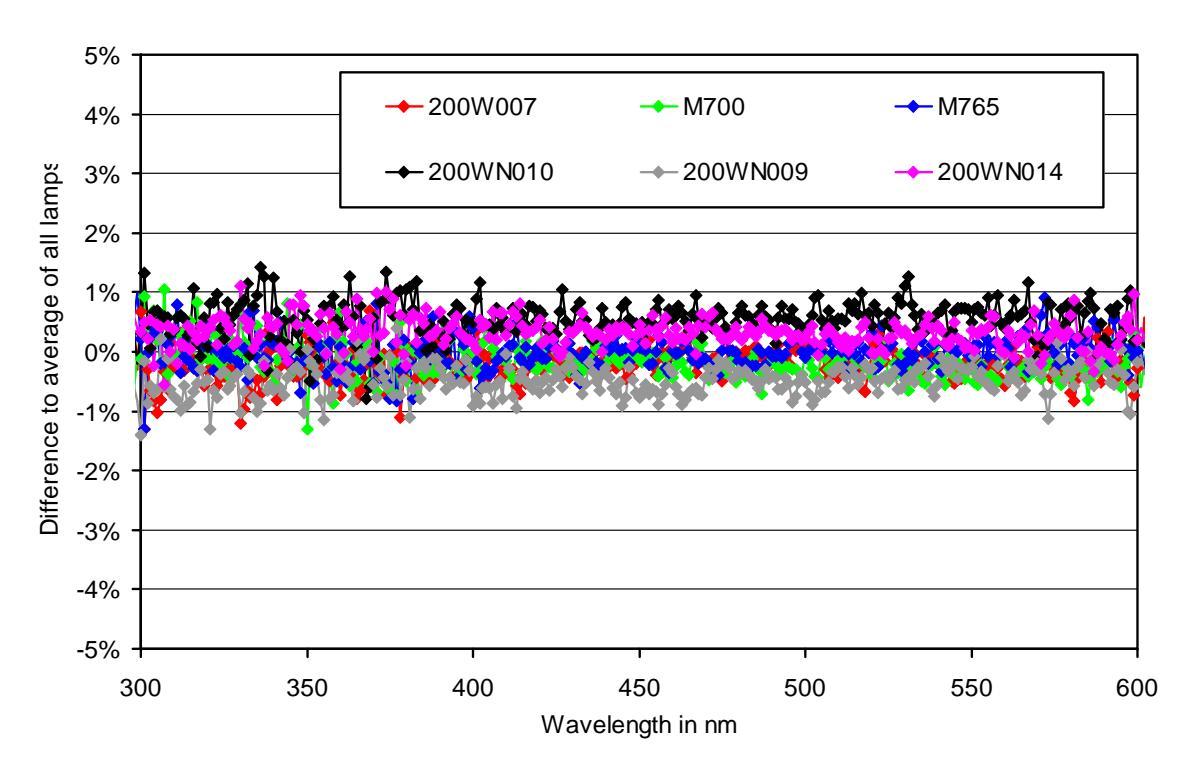
Figure 1 shows a comparison of all lamps performed on 3/25/19, at the start of the site visit. The scales of spectral irradiance of all lamps agree to within $\pm 0.6\%$.

Figure 1. Comparison of the calibration of on-site standards 200W007, M700, and M765 with long-term standards 200WN009 and 200WN010, and the traveling standard 200WN014 on 3/25/2019.

The "working standards" 200W007, M700, M765 had not been calibrated for several years and the comparison with the long-term standards and the traveling standard 200WN014 (see below) indicated that the scales of the lamps have changed by 1-2%. Consequently, the lamps were recalibrated against the traveling standard using absolute scans taken at the start of the site visit. Please see previous Operations Reports for the calibrations history of the three working standards.

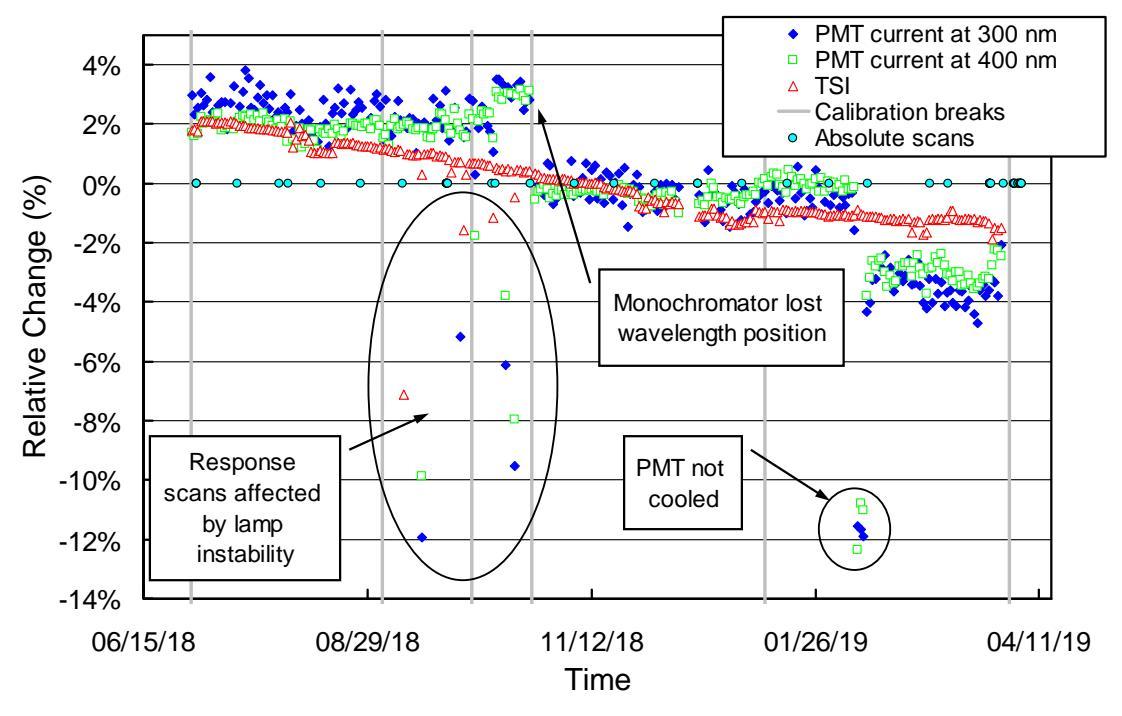
Figure 2 shows changes in TSI readings and PMT currents at 300 and 400 nm, derived from response scans performed between 7/1/18 and 3/29/19. TSI measurements decreased by about 4.0% during this period, indicating that the response lamp became darker by this amount. PMT currents also decrease, however, PMT data are affected by several step changes that are not seen in the TSI data.

- Between 10/22/18 and 10/23/18, the PMT signals abruptly decreased by about 3%. This step change occurred when the system's monochromator lost its wavelength position following an absolute scan. Over the following day, the system was scanning over a different wavelength range than usual. After the wavelength registration was restored, the system's sensitivity was lower, suggesting a change in the monochromator's throughput. The calibration was adjusted accordingly and solar data are therefore not affected.

- On 2/9/19, PMT currents dropped by about 12% when the fuse of the device that cools the PMT blew. The fuse was replaced on 2/11/19. However PMT currents measured after 2/11/19 remained lower relative to those recorded before the failure of the fuse. This suggests that the PMT temperature was not as low as initially. Inspection of the system during the site visit revealed that the fan of the PMT cooler fan was not working properly and was successively replaced. The malfunction of the fan likely caused the fuse to blow and also explains the larger PMT temperature observed after the fuse was replaced. The effect on solar data is minimal as "pairing" with the daily response scans corrects for changes in system responsivity.

- Eleven response scans of the reporting period resulting in low TSI and PMT readings. The problem was most obvious in September and October 2018 (indicated by the ellipse in Fig. 2). The problem could have been caused by instability of the response lamp or by poor electrical contact between the lamp and its socket. Associated response scans were not used for processing of solar data.

Figure 2. Time-series of PMT current at 300 and 400 nm, and TSI signal. All data were extracted from measurements of the internal irradiance standard and are normalized to their average. Calibration break points (Table 1) and times of absolute scans are also indicated.

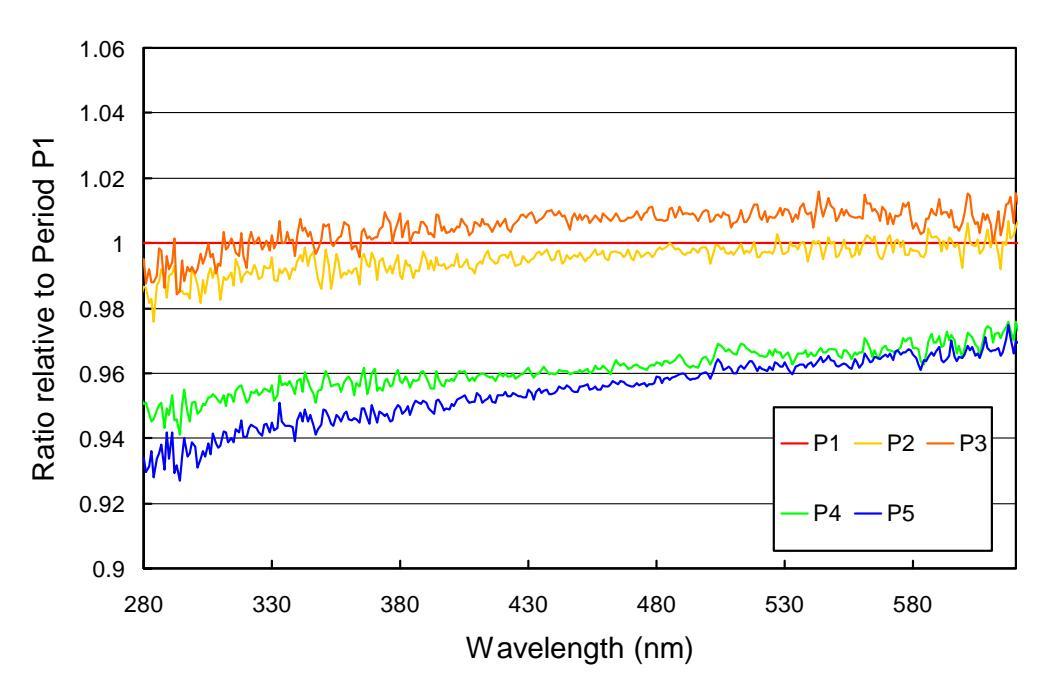
The reporting period was divided into five calibration periods, labeled P1 - P5 (Table 1). Figure 3 shows ratios of the calibration functions applied during Periods P1 through P5 relative to the function of Period P1.

Figure 3. Ratios of spectral irradiance assigned to the internal reference lamp for periods P1 - P5 relative to Period P1.

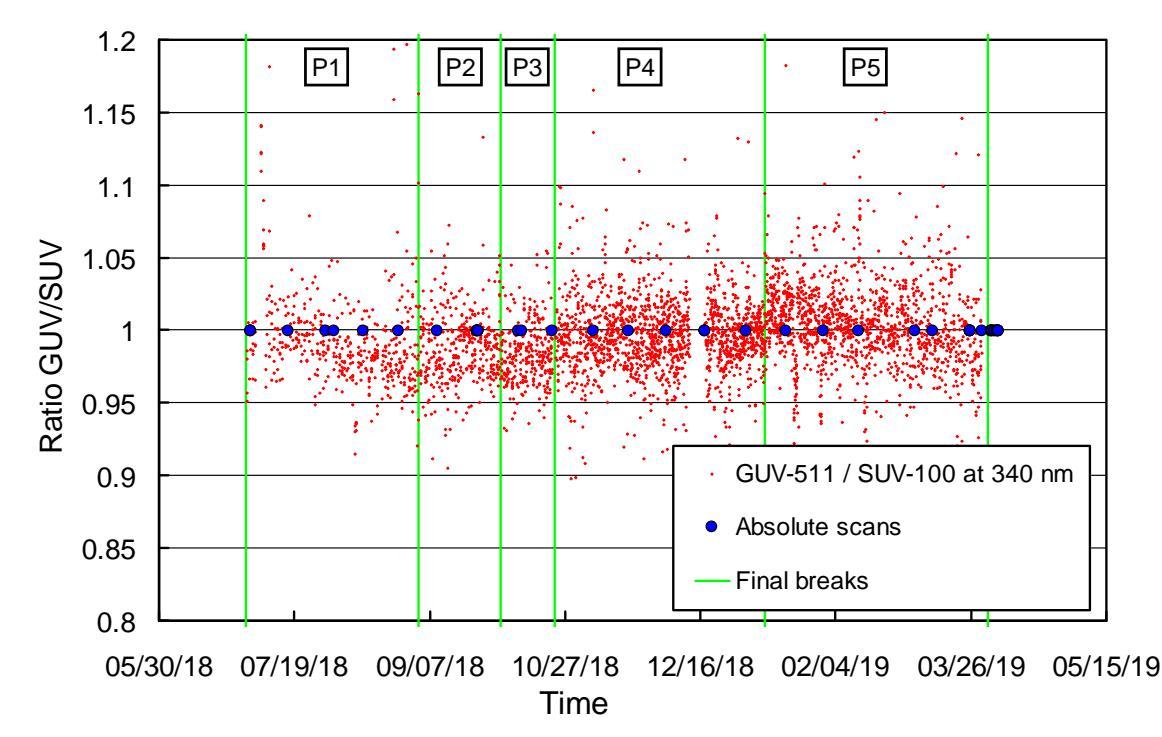
The suitability of the selected calibration break points was checked by comparing calibrated SUV-100 measurements with GUV data. Figure 4 shows the ratio of GUV-511 data (340 nm channel) and final SUV-100 measurements, which were weighted with the spectral response function of this channel. The ratio is normalized and should ideally be one. There are virtually no step-changes at times of calibration breaks (green vertical lines), indicating that solar data of the SUV-100 have been appropriately corrected. GUV and SUV measurements typically agree to within $\pm 5\%$. However, Figure 4 also shows a few short periods when the ratio is abnormally high (e.g., on 7/5/18 - 7/7/18, 7/30/18, 8/1/18, 8/19/18, and 11/5/18). On these days, snow was presumably covering the irradiance collector of the SUV-100 spectroradiometer for short periods. GUV measurements are less affected by snow because the instrument is heated to a higher temperature. Hence, the ratio of GUV and SUV measurements is high after heavy snowfall until the SUV collector is again free of snow. When disregarding periods affected by snow, GUV and SUV are consistent to within $\pm 2.6\%$ ($\pm 1\sigma$). SUV measurements influenced by snow are part of the Version 0 and 2 datasets, and have been flagged in the Version 2 dataset.

Figure 4. Ratio of GUV-511 measurements at 340 nm with final SUV-100 measurements. The latter were weighted with the spectral response function of the GUV-511's 340 nm channel. Narrow clusters of vertical data points are caused by snow covering the SUV-100 collector.
